CONDITION REPORT OF THE TOMB OF A NOBLEMAN (TT 65) IN THEBES¹

Eszter Harsányi–Zsófia Kurovszky–Erika Vadnai–László Kriston

RESTORER'S APPRAISAL OF THE TOMB

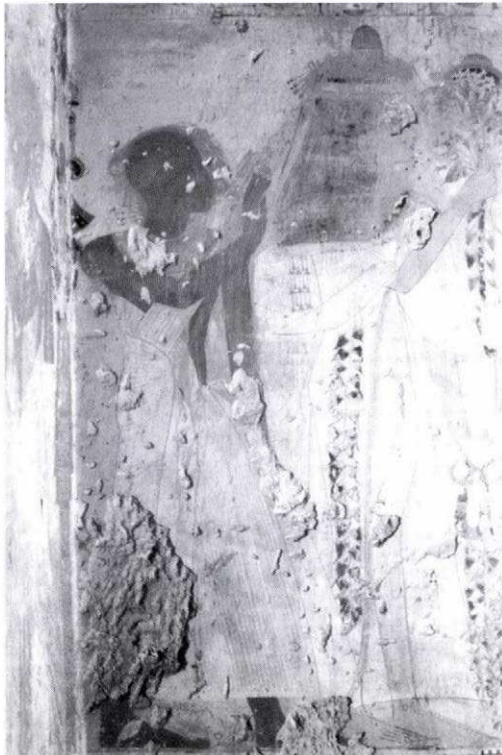
4. Imiseba's great grandmother from the life-size depictions of the relatives. It can be seen on the damages how the Copt anchorites, for fear of demons, ruined the figural paintings.

Three hundred years later the above mentioned priest of Karnak chose the abandoned tomb for his burial place, towards the end of the New Kingdom when Egypt's position as a great power was declining and when decorated rock tombs became a rarity. He enlarged the tomb with an about 10 m long undecorated axial corridor perpendicular to the first colonnaded chamber, and a so-called "sloping passage" leading from it deep into the hill with a burial chamber cut at the end of it. (fig. 3). Earlier reliefs were plastered over and had the walls and the ceiling richly decorated with paintings and minutely elaborated hieroglyphic texts. He broke with the traditional depiction of picture strips, and arranged the scenes in panels. He intended to create an imitation of the burial temples of rulers and the tombs of the kings, and that is where the archetypes of the decoration of the tomb should be looked for. He supplemented these motifs with personal elements such as the life-size depiction of his own relatives⁷ (fig. 4).

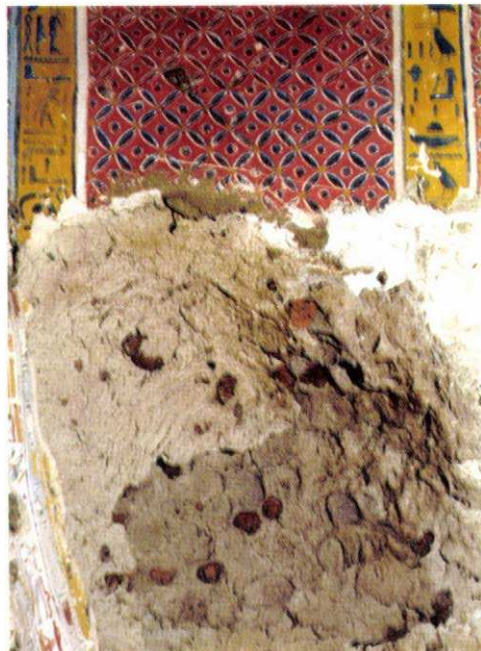
6. Detail from the north-western corner of the ceiling of the transverse-hall. Donkey excrements and their imprints and traces of the handwork can be seen in the mortar.

compared to its volume and it most probably fits the purpose, although, in the lack of scaffolding we could not closely inspect it on the ceiling. However, all the local people who carried water from the central well on the back of donkeys agreed that the brown globules certainly came from this animal. It could clearly be seen, even without scaffolding, that the mud plaster has conserved the fingerprints of the workers for more than 3000 years (fig. 6).

The colours were mixed with the binding material in advance for the surface to be painted in a single phase. When they ran out of paint, another batch was made. Several examples show that they did not always succeeded in mixing exactly the same hues. In the ornamental textile motifs on the ceiling, the change between the sections made with freshly mixed colours can often be observed. These sections can, as well, indicate a day's work. The density of the paint also changed within these sections. It can be observed that when only a little paint was left it was diluted several times to postpone the mixing of a new batch. Accordingly, the about 9x1 m large stripe was made in three phases (fig. 6).

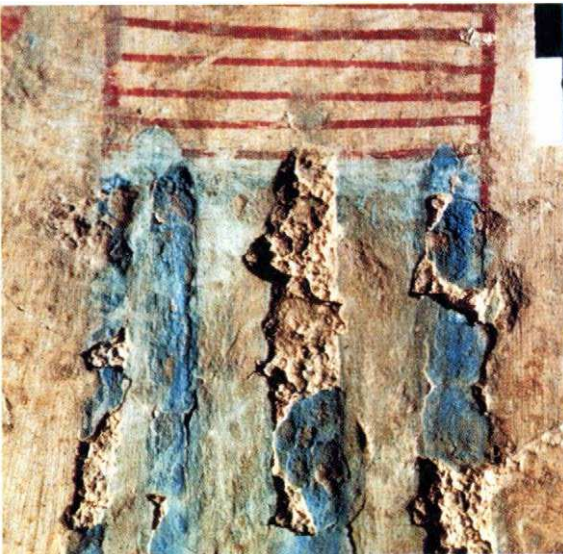
8. Macrophoto of the southern rear wall. It shows the bound stalks of a bunch of lotus flowers at the foot of the richly laden altar that stands in front of Osiris.

The organic binding material used on Egyptian wall paintings could be wax, vegetal resins,¹⁶ glue, egg, lime, etc according to the descriptions.¹⁷ We found that white and yellow pigments were the best preserved in the tomb. Blue was evidently applied in a thicker layer. Motifs painted in this colour often got completely dislodged and fell out of the surface leaving a negative impression on the naked plaster. One of the explanations of the phenomenon can be that pigments of large grain sizes need much binding substance, sometimes more than the proportion of the colour-bearing component. When the binding substance dries, it shrinks, which can tear off the paint. The same problem could be observed in several tombs in Thebes especially on details painted in blue¹⁸ (figs. 8, 9).

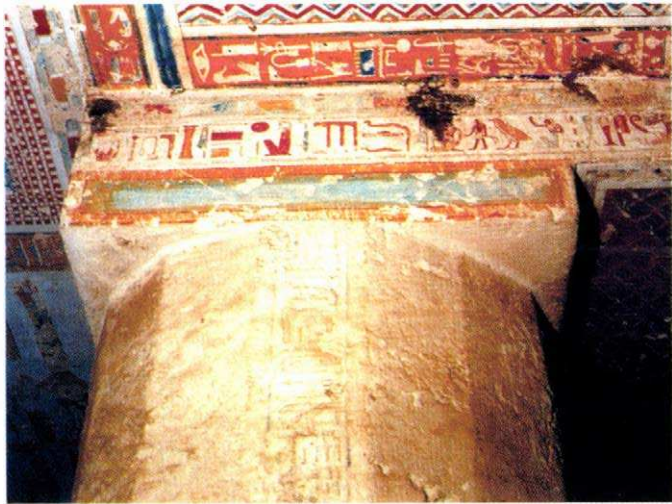
9. The western side of column d in the transverse-hall. A meticulously painted, coloured hieroglyph text runs on the side of the carved architectural element that imitates a stone beam laid horizontally on top of the columns. The inscriptions painted in blue above it on the ceiling all fell out.

Fruit bats preferred the joining of the vertical walls and the ceiling, especially close to the corners, where they demolished the painted layer of the ceiling and left large brownish black spots on the vertical walls. Where the depositions measure several millimetres, they totally cover the surface. At the edges, nevertheless, the surviving inscriptions could be seen under the thinner layers (fig. 9).

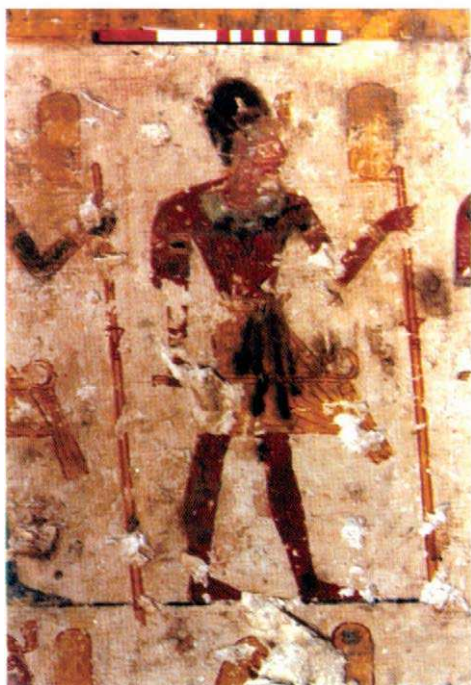
10. Imiseba had the figures of the twelve pharaohs he revered the most painted beside the scene of Ramses IX's offering on the southern end wall of the transverse-hall. The black layer applied on the jewellery of the kings does not match the carefully elaborated depiction. It can be seen beside one of the kings that the names painted in black on the yellow background of the cartouches have faded.

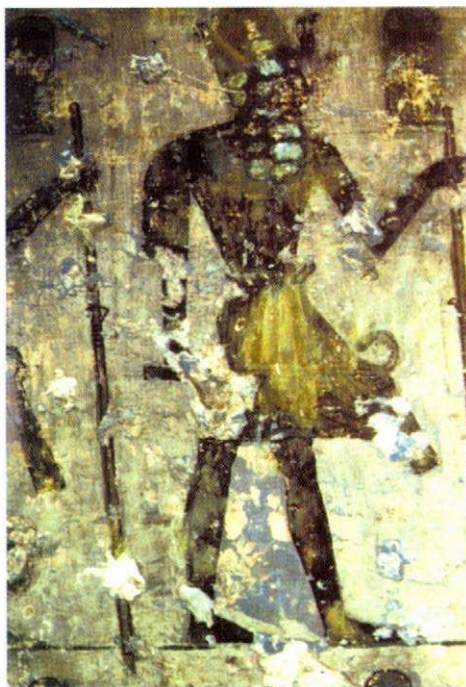
11. Strong luminescence characteristic of organic materials can be observed on the crown, the necklace and the apron in the luminescent photo of the king.

The roughly prepared surfaces were plastered with different materials in an average thickness of 3-5 cm reaching 10 cm at some places. The smoothed walls have an uneven surface, depressions and that even palm sized areas are not free from protrusions. A many-layered, light coloured plaster was applied in the transverse-hall. The luminescent photos made of the southern end wall in ultraviolet light (366 nm) revealed interesting pieces of information about the rock, the plasters, the priming and the paint layer. A plaster layer could clearly be separated from the rock, it was covered with a thinner, 0.3-1 cm thick light coloured grounding then a lighter coloured background layer on which the paint was applied (fig. 11).

The cell structure nests of mud daubers can be found on almost all the walls. Round these nests the painted layers are sometimes totally worn off. They stick solidly and strongly to the surface and the holes with which they were fixed can reach 1-1.5 cm deep into the plaster.²² It can be seen in the luminescent photo taken of the place of a removed nest that the surviving painted surface is strongly luminescent under the nest and is covered with an organic layer (fig. 11).
